1992-1999 BMW 3 Series Brake Light Bulb Replacement

This guide will walk you through how to replace the brake light bulb on your 1992-1999 BMW 3 Series quickly and easily.

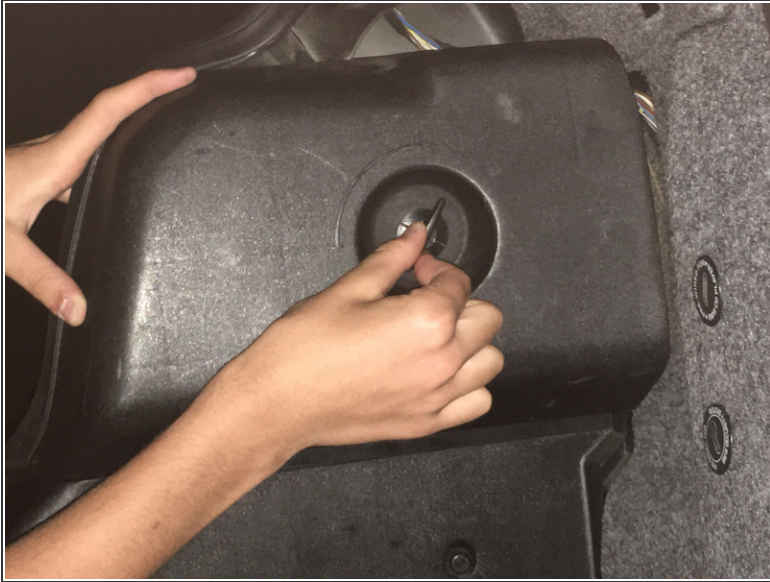
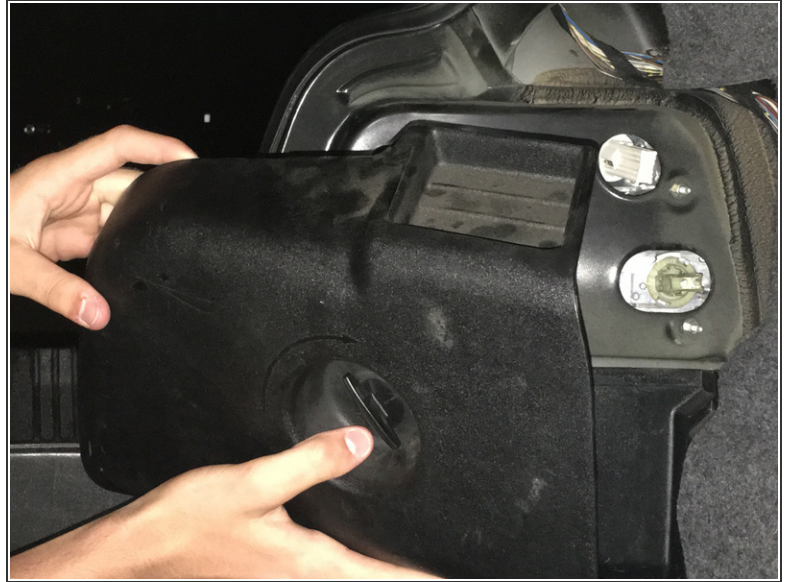
Step 1 — Brake Light Bulb

- Determine which brake light is out. Have a friend step on the brake and see which light does not illuminate.
- In the trunk, locate the plastic cover that protects the taillight. Turn the handle clockwise (as shown by the arrow above the handle) and gently pull outwards.

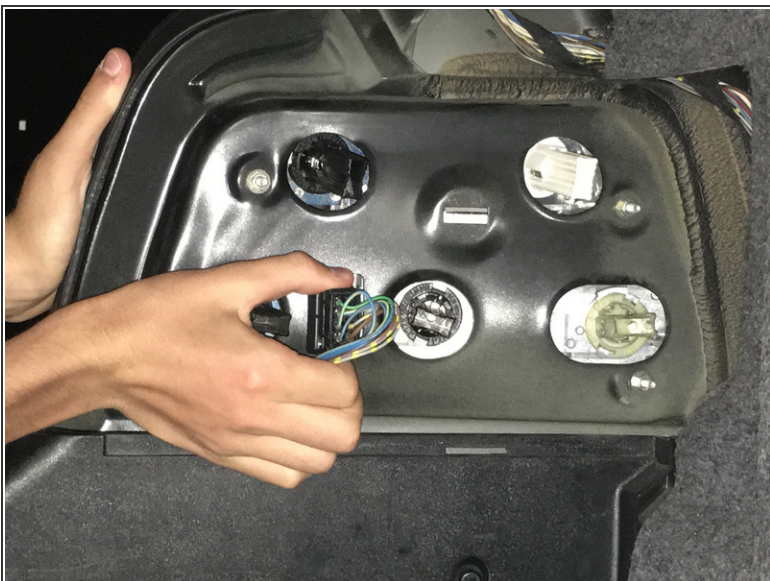
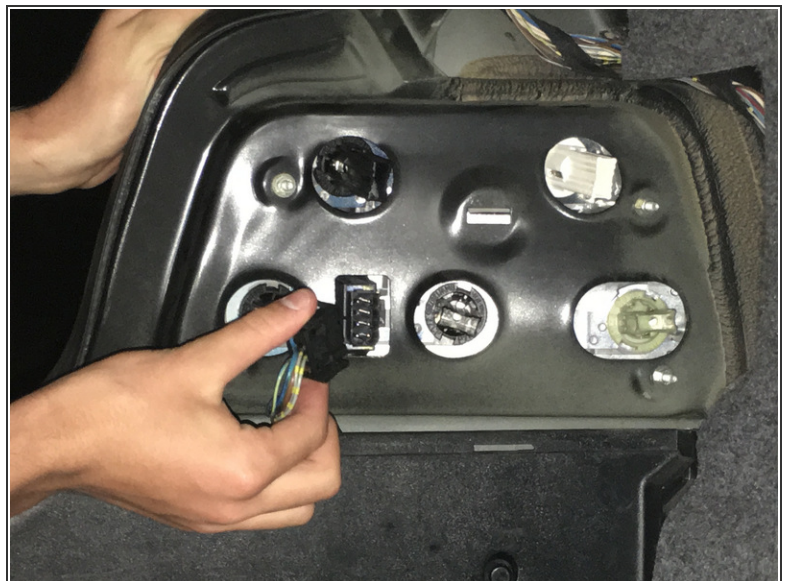
Step 2

- Pinch the top and bottom of the power connection. Pull hard on the power connection to remove it; this disconnects the power.

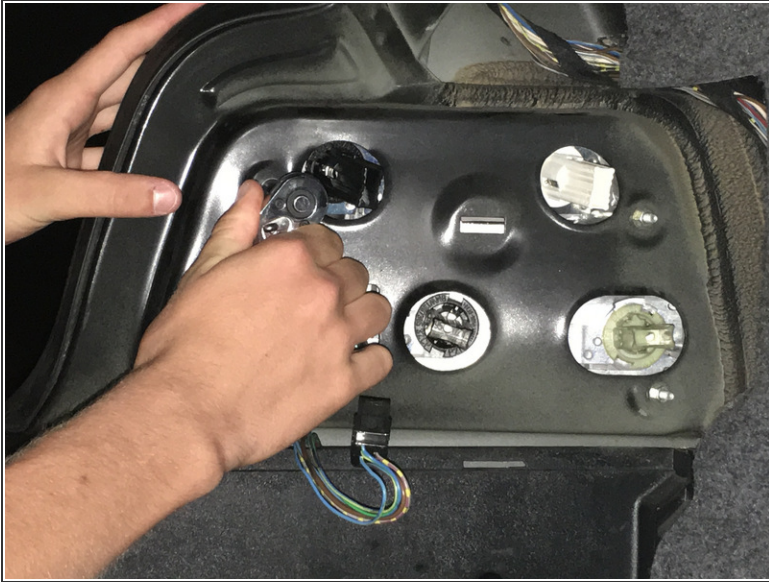
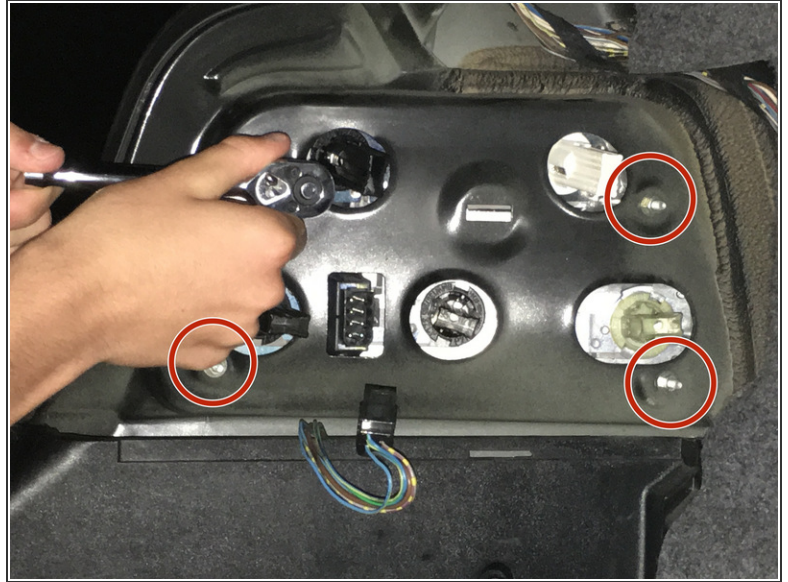
Step 3

- Undo all four nuts with the 8mm socket and ratchet.
- The nuts are found on the corners of the taillight

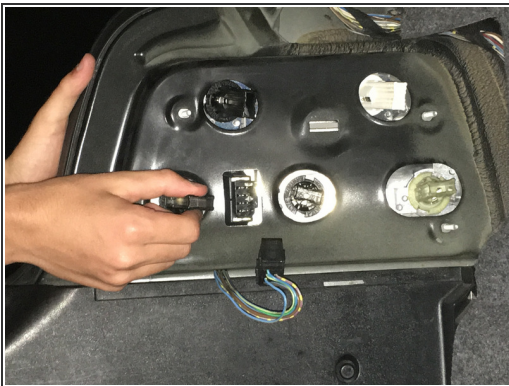
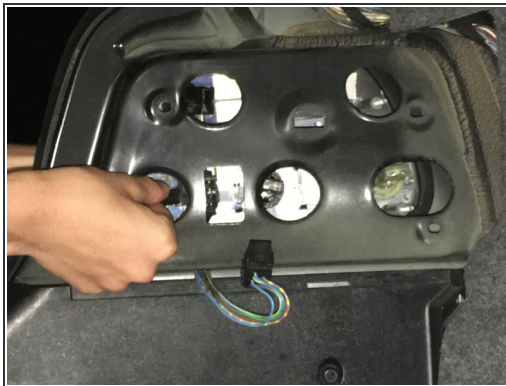
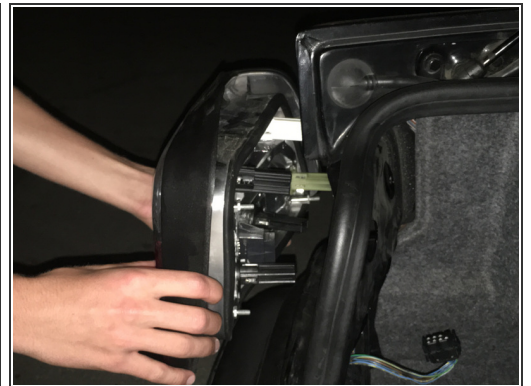
Step 4

- To remove the taillight from the metal frame, push outwards (towards the back of the car) on the back of one of the plastic bulb carriers.
- Have one hand support the other side of the taillight to prevent it from falling and cracking the plastic.

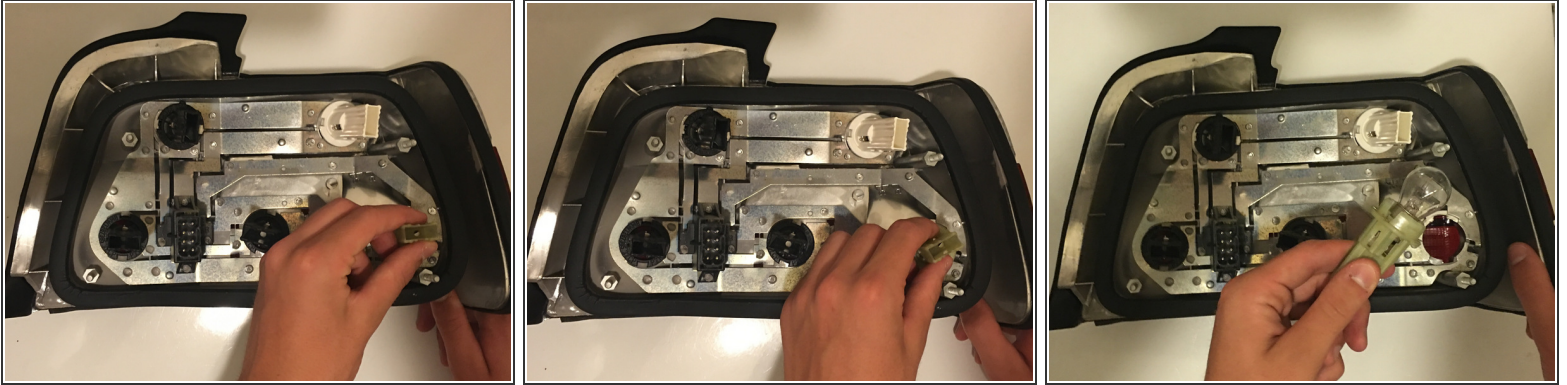
Step 5

- The brake light bulb is the bottom right bulb. Push this bulb inwards and turn it counterclockwise, with lots of pressure, to remove it.

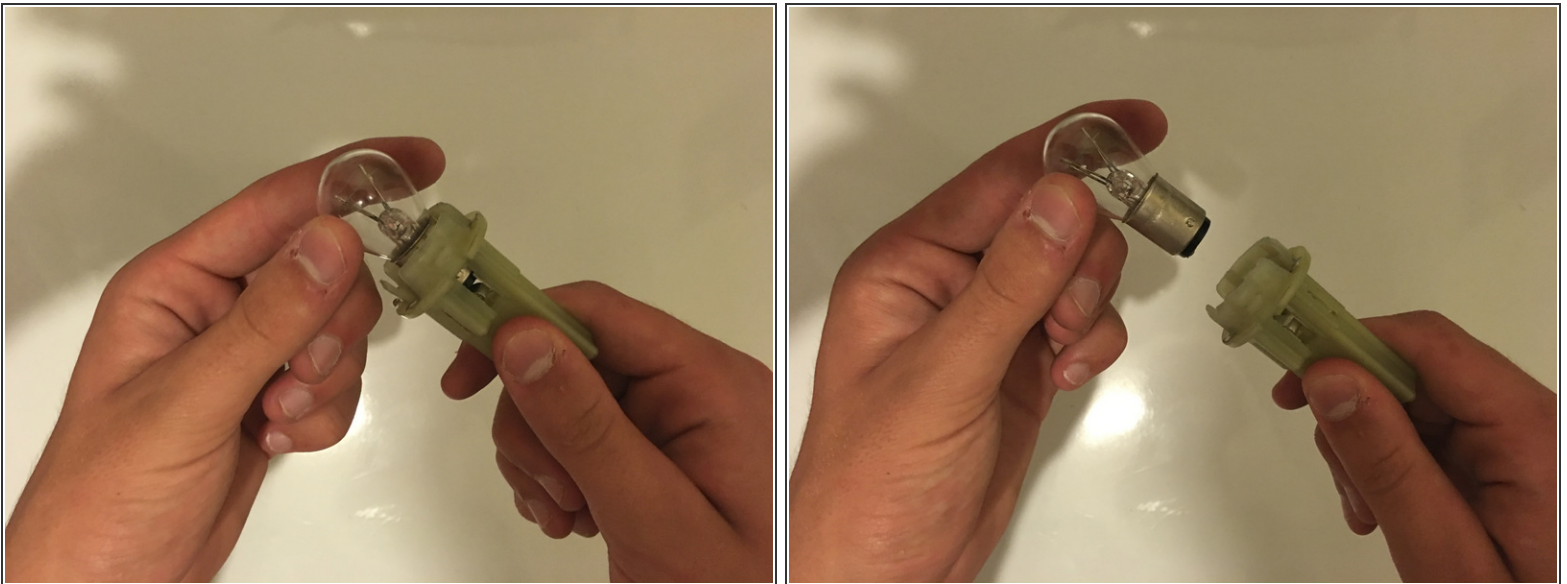
Step 6

- The 7528 bulb is in the off-white plastic carrier. Apply slight pressure downwards and twist counterclockwise to remove the bulb.

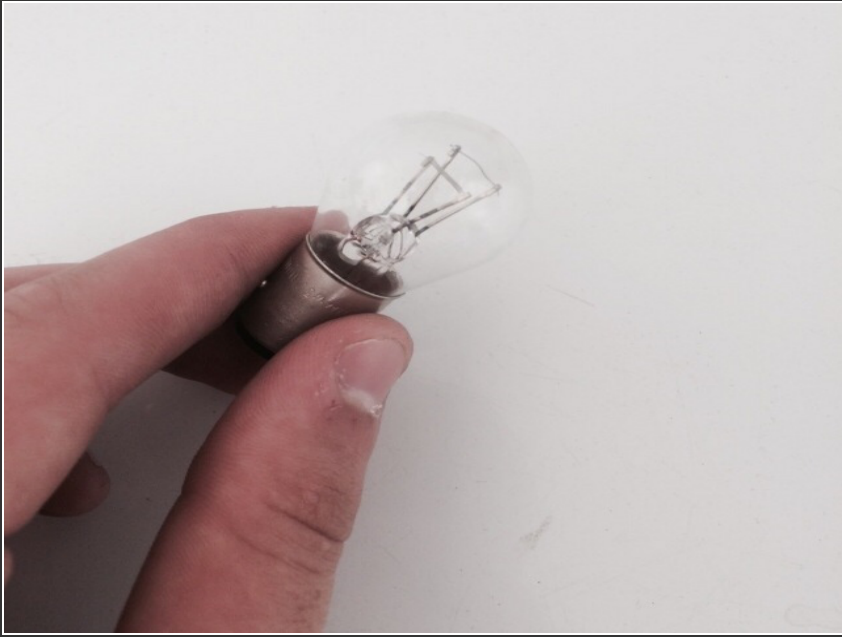
Step 7

- To determine whether or not a bulb is burnt, check for a connection break in the bulb. In the image shown, wires run continuously between both connections. This means the bulb is not burnt and is set to be put back in the taillight.
- Take the new 7528 bulb and place it in the same plastic that held the burnt bulb.

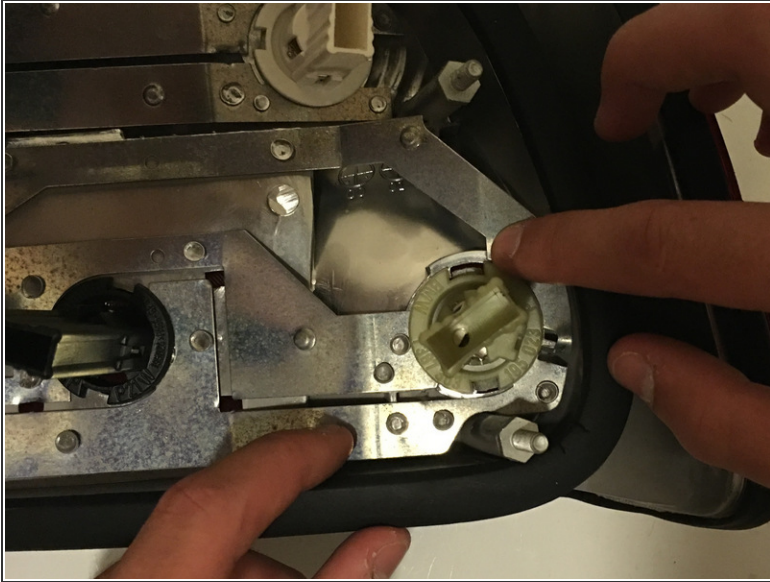
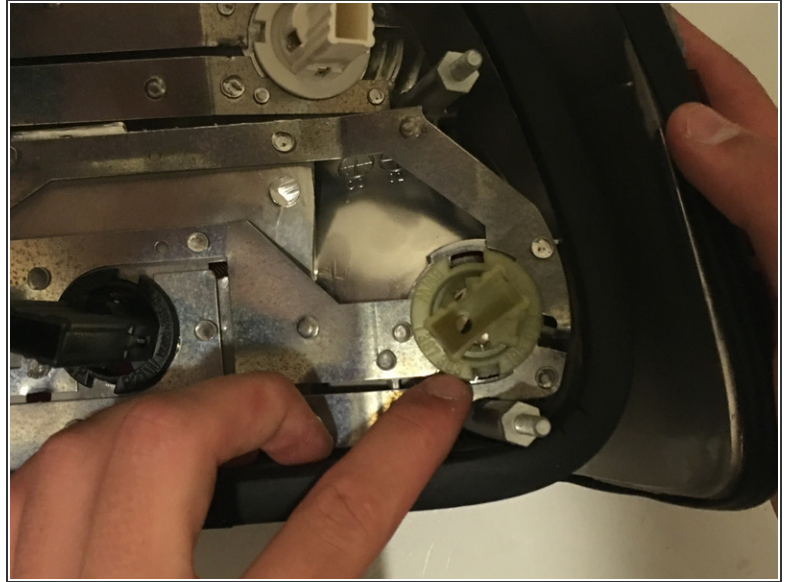
Step 8

- The plastic carriers only fit into the taillight carrier one way. The fit is very snug against the metal ground.
- Align the two plastic tabs with the indents in the metal sheet. Push hard inward while twisting clockwise until the bulb is horizontal, similar to the other four bulbs. When the bulb fits correctly, you will hear a loud snap.
- ⓘ Note: The bulb carrier is very hard to place correctly. Ensure the tabs are lined up, and apply hard pressure while turning clockwise. If the bulb carrier does not sit properly, remove it and reseal it.
